CREEP DAMAGE OF LOW-ALLOY STEELS AFTER LONG-TERM EXPOSURE AND ITS EVALUATION BY REPLICA METHOD

Zdeněk KUBOŇ [1], Jana KOSŇOVSKÁ [1], Ladislav KANDER [1],

[1]*Material and Metallurgical Research (Ltd.), Vítkovice,703 00 Ostrava, Czech republic, EU*
zdenek.kubon@mmvyzkum.cz

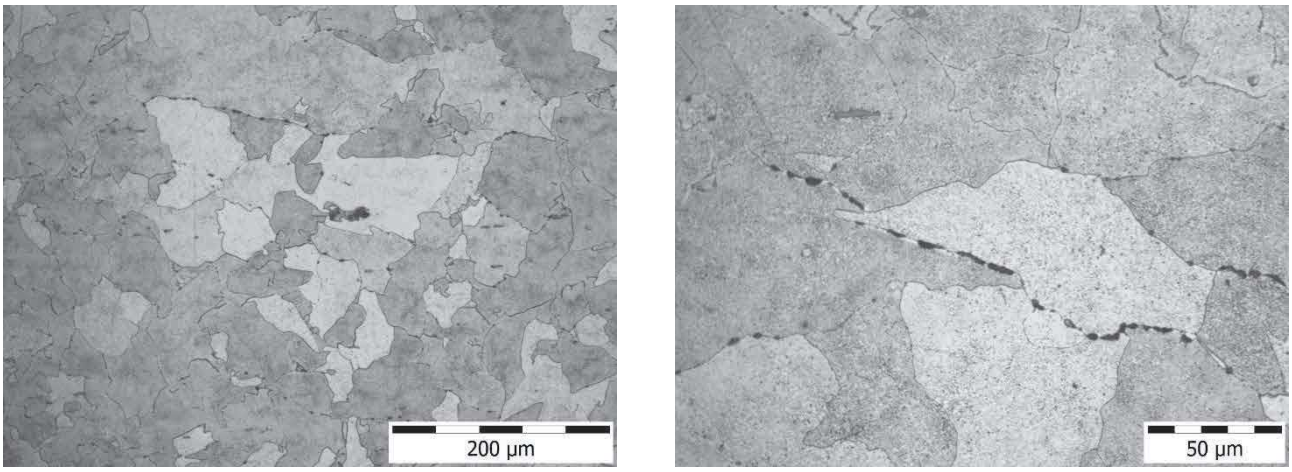
Analysis of cavitation damage confirmed the results of replica testing and numerous chains of cavities of length not exceeding 200 μm were observed both on the outer surface and under it in depth 5 mm, see **Figures 1** and **2**. At a depth of 10 mm, chains of cavities were observed mainly locally and isolated cavities were detected in small amounts, see **Figure 3a)**. At a depth of 15 mm below the outer surface of the pipe bend, the number of cavities was further reduced, the chains of cavities were recorded only sporadically and the presence of isolated cavities was relatively limited, too, see **Figure 3b)**. Finally, at a depth of 20 mm, the number of cavities was further reduced and the only isolated cavities were recorded, see **Figure 4**.

Figure 1 Cavitation damage on the outer surface of the steam pipe bend (overall view and detail)

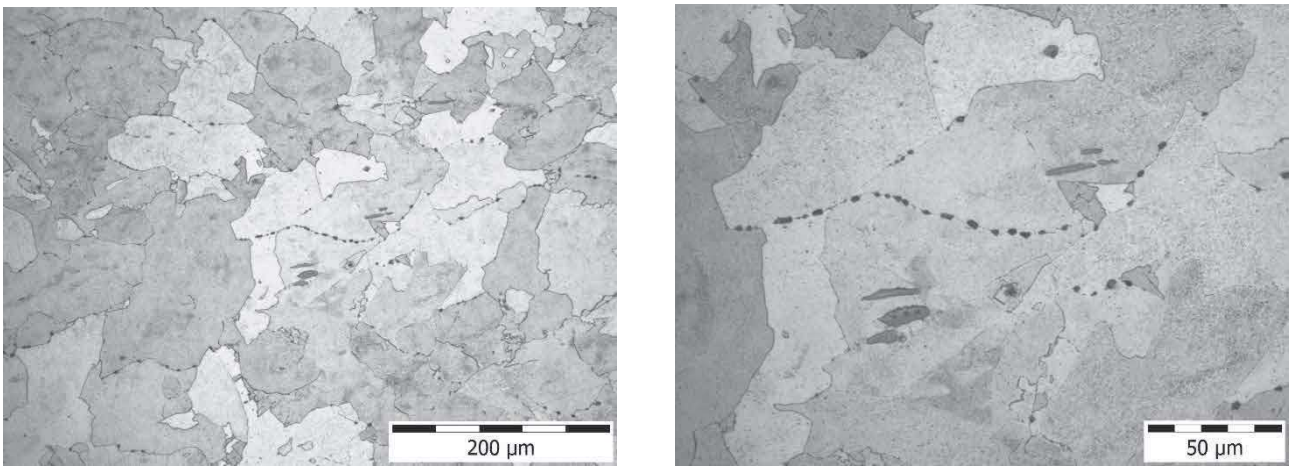
Figure 2 Cavitation damage 5 mm under the outer surface of the steam pipe bend (overall view and detail)

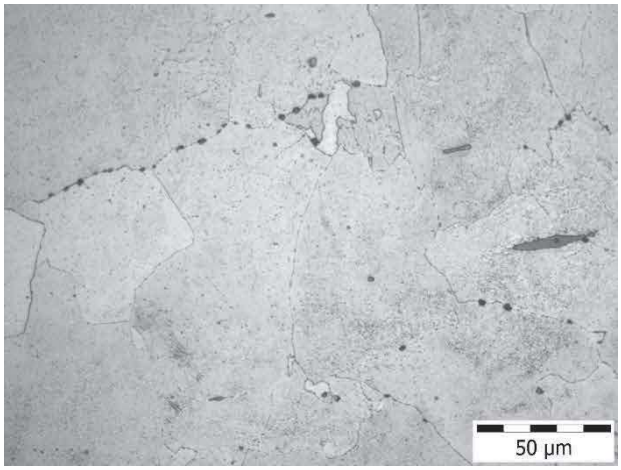
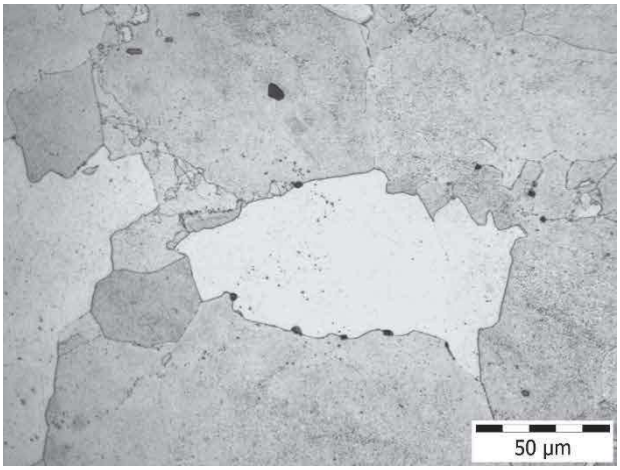
Figure 3 Cavitation damage 10 mm (a) and 15 mm (b) under the outer surface of the steam pipe bend

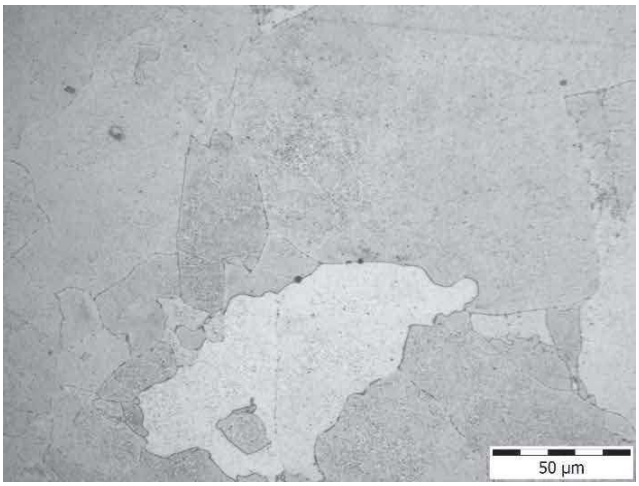
Figure 4 Isolated cavities 20 mm under the outer surface of the steam pipe bend

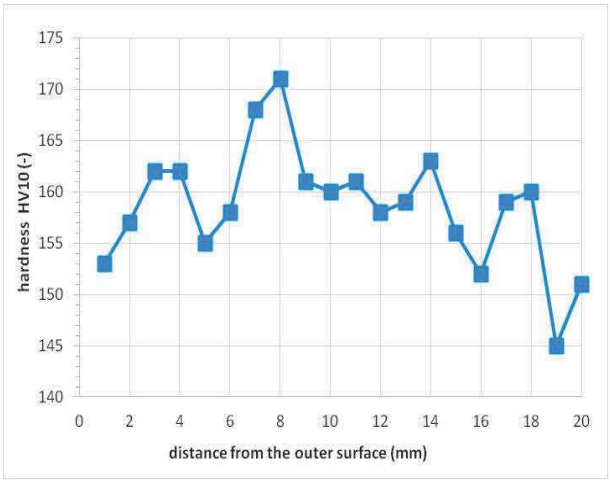
Figure 5 Hardness profile through the wall thickness

Additional hardness measurements through the wall thickness of the pipe bend were performed with the aim to find out how the cavitation damage affects mechanical properties of material. Hardness (HV10) was measured with a distance between indentations approximately 1 mm, conventional tensile tests and small punch tests samples were prepared as close to the outer surface as possible. The results showed slight hardness increase from the outer surface to 8 mm under the surface and then hardness decline towards inner surface, which is surprising in context of cavitation damage, more or less fluently decreased from the outer to inner pipe surface.
